E.E.S. REPORT C-3599-A(2)
30 MARCH 1950

UNITED STATES NAVAL
ENGINEERING EXPERIMENT STATION

ENDURANCE TEST OF
PHILIPS MODEL 1/4D EXTERNAL COMBUSTION ENGINE

By
Alan R. Schrader
14 Alan R. /Schrader
Small Diesel Engine Branch
Internal Combustion Engine Laboratory

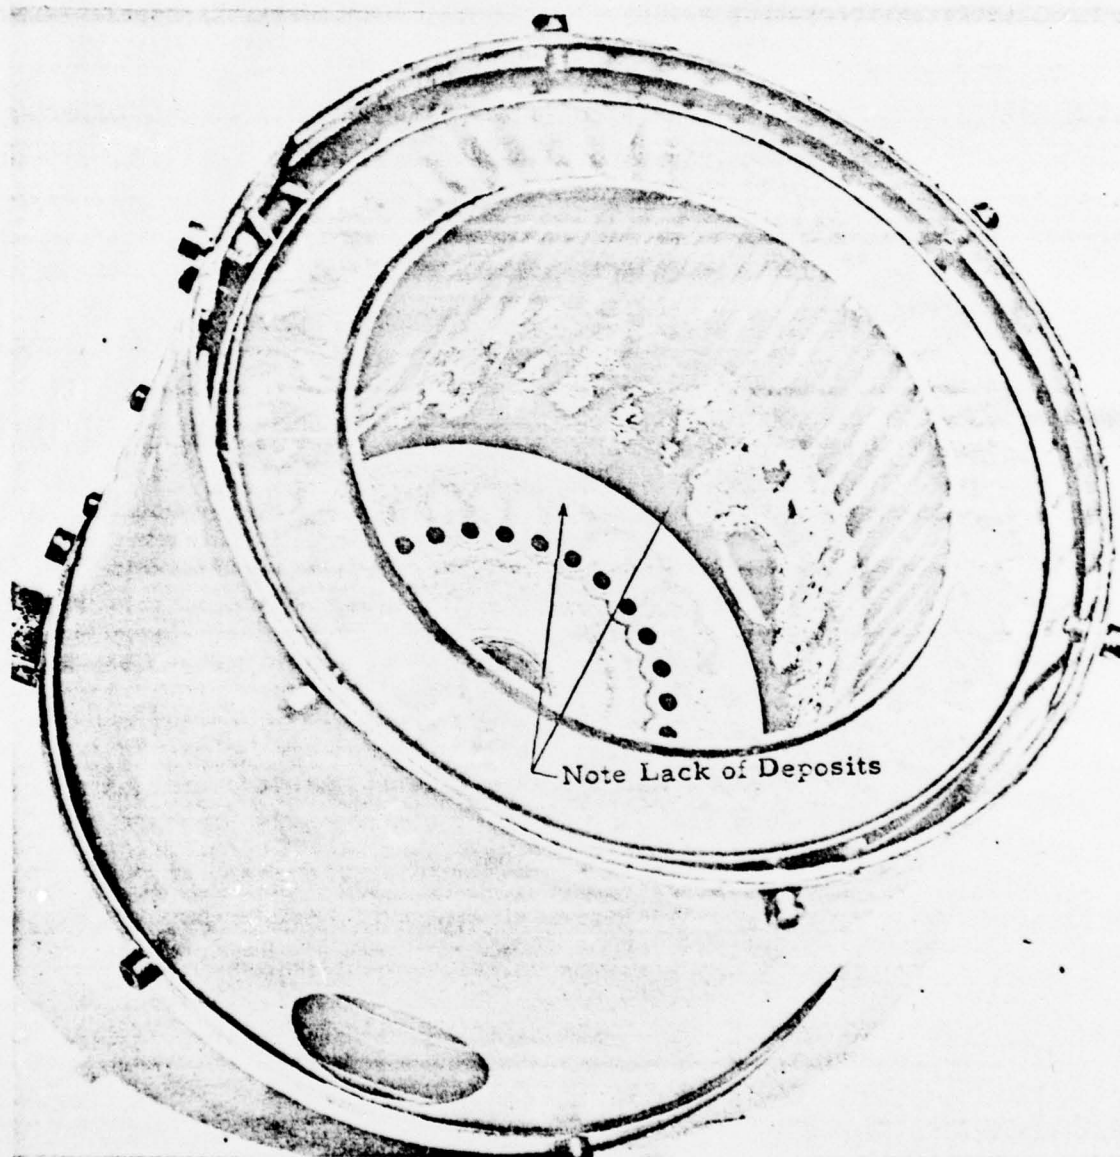
PHILIPS MODEL 1/4D ENGINE BURNER HEAD
FOLLOWING 500 HOURS OPERATION ON UNLEADED GASOLINE

16. Inspection of the burner and heater heads following 500 hours operation with Amoco water white (lead free) gasoline showed them to be free of appreciable deposits, Plates 7 and 8. Cleaning of the parts was considered unnecessary. A second inspection of these surfaces following 30 hours subsequent operation with 80 octane leaded motor fuel again showed them to be satisfactorily clean, Plates 9 and 10; cleaning was again considered unnecessary.

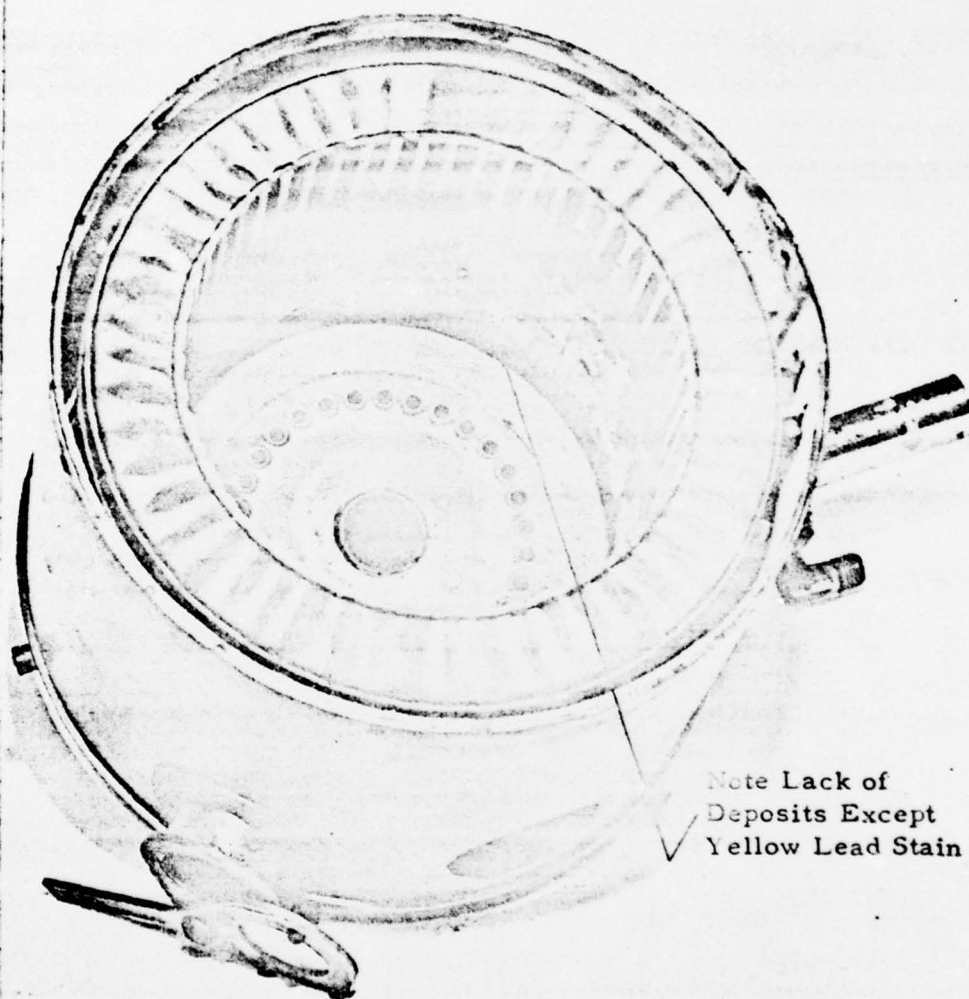
PHILIPS MODEL 1/4D ENGINE BURNER HEAD
FOLLOWING 30 HOURS OPERATION ON 80 OCTANE GASOLINE
AND 500 HOURS OPERATION ON UNLEADED GASOLINE

Note Lack of
Deposits Except
✓ Yellow Lead Stain

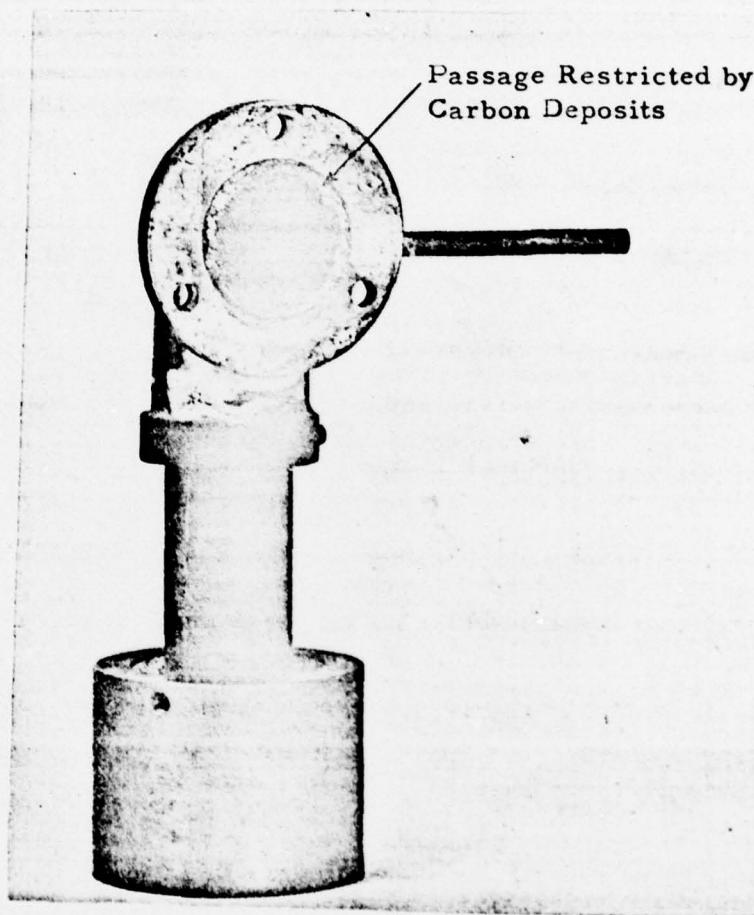
PHILIPS MODEL 1/4D ENGINE
GASOLINE-AIR MIXTURE VENTURI TUBE
250 HOURS OPERATION

(c) Heavy carbon deposits in the gasoline-air mixture venturi, Plate 11, prevented proper combustion after 250 hours operation. The deposits were removed by scraping. Similar but considerably lighter deposits were removed after 431 hours operation of the engine; it was uncertain whether the deposits affected engine operation on this occasion.

30. The build-up of carbon deposits in the gasoline-air mixture venturi tube, Plate 11, appears to be an inherent fault of the combustion system used on this engine. The tube is hot during operation, because of heat conduction from the burner head. Its inner surface is wetted by a coarse spray of gasoline. This creates a favorable condition for carbonization of the gasoline. It is necessary that the tube operate at a high temperature in order to gasify the fuel before it reaches the combustion chamber.

31. The above-described carbon deposits definitely interfered with proper engine operation on only one occasion, after 250 hours operation, although the deposits were cleaned out after 431 hours operation during attempts to correct low heater head temperatures. In the latter case, however, the difficulties appeared to have been caused by nozzle fouling. The carbon deposits are not regarded as a serious problem in this engine. Removal of the deposits is a simple operation and very little disassembly is required.

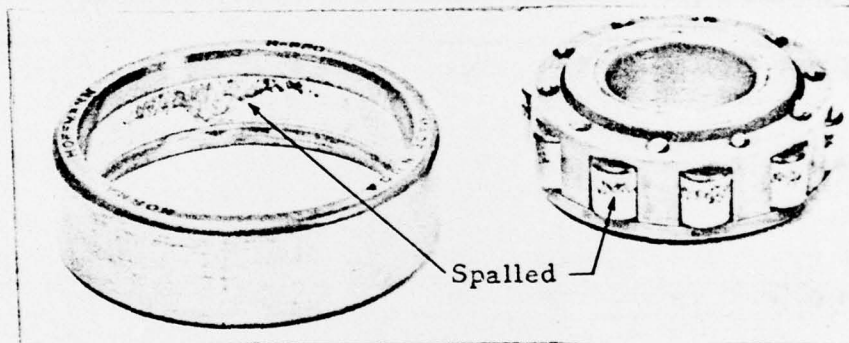
PHILIPS MODEL 1/4D ENGINE
MAIN ROLLER BEARING
597 HOURS OPERATION

(g) The crankshaft main roller bearing failed after 597 hours operation, Plate 13.

(a) The main roller bearing had failed by spalling, Plate 13.

(c) The main roller bearing failed by spalling after 597 hours operation, Plate 13.

35. The crankshaft main roller bearing that failed after 597 hours operation, Plate 13, was installed new immediately prior to shipment of the engine to this Station, according to information supplied by Mr. R. L. Adams of the Philips Laboratories. He further advised that while considerable difficulty with this bearing had been experienced during the earlier development work on the engine, the trouble had apparently been corrected by use of a narrower bearing and by the elimination of needle bearings in the engine.

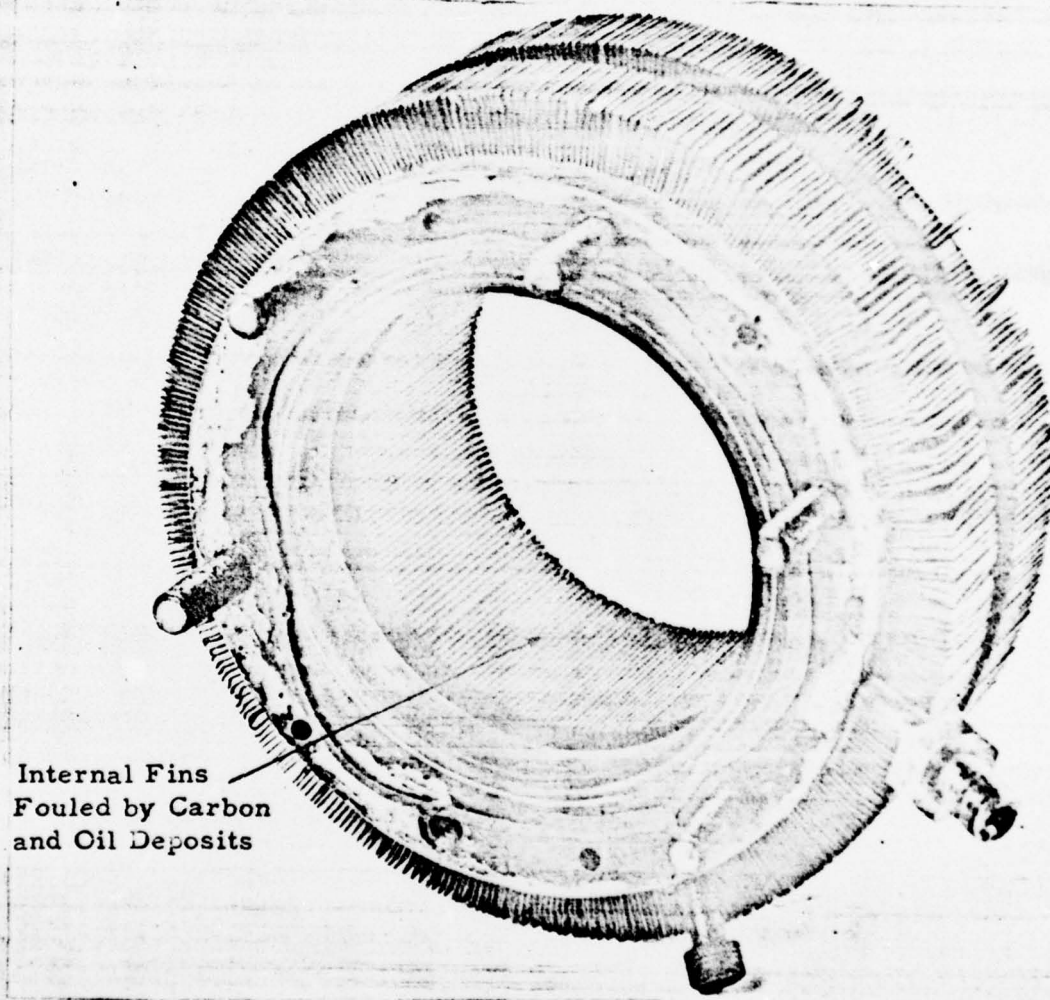
PHILIPS MODEL 1/4D ENGINE
COOLER BLOCK
597 HOURS OPERATION

(b) The internal fins of the cooler were coated with an oily carbonaceous deposit, Plate 16. It is estimated that the flow restriction due to the deposit was 10 percent or less.

36. Fouling of the internal fins of the cooler, Plate 16, at the post-trial disassembly, appeared to be moderately serious. This was the apparent cause of the increase in temperature of the cooler during the latter part of the endurance run, Plate 5. It is pointed out, however, that in spite of this fouling and the main bearing failure, the engine still developed more than its rated power, 124.5 watts, when secured at the end of the endurance run, Plate 5.

Internal Fins
Fouled by Carbon
and Oil Deposits

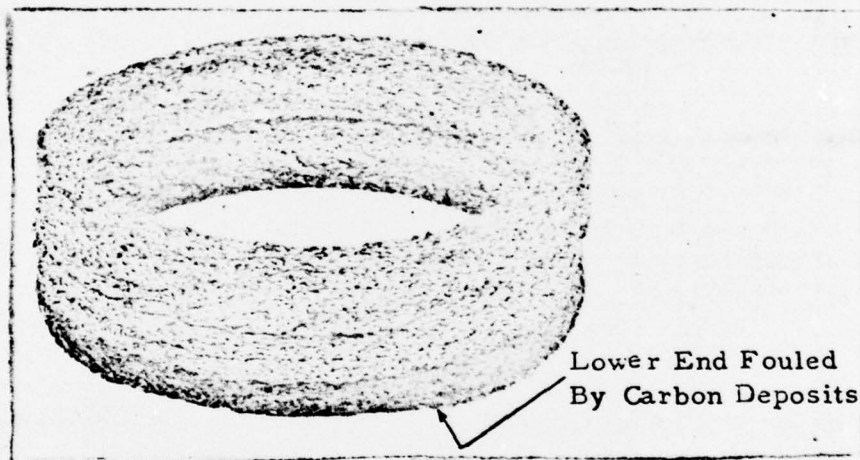
PHILIPS MODEL 1/4D ENGINE
REGENERATOR
597 HOURS OPERATION

(c) The lower quarter of the regenerator was blackened by carbon and oil deposits, Plate 17. The balance of the regenerator appeared to be relatively clean, although it was dulled and heat-colored.

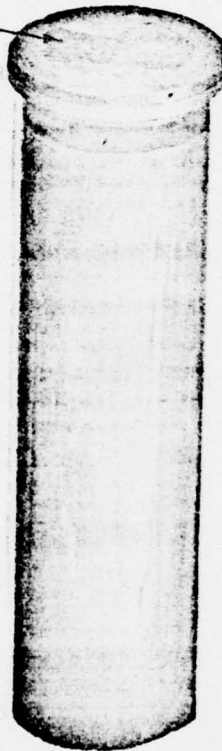
PHILIPS MODEL 1/4D ENGINE
COMPRESSOR PISTON
597 HOURS OPERATION

(d) The tappet surface of the compressor piston was indented and pitted from contact with the crankpin bearing, Plate 18.

37. The excessive wear and indentation of the compressor piston tappet face, Plate 18, was due to the inadequate hardness of that surface. According to the contractor's drawing of this part, cold rolled steel without any hardening procedure was specified.

Tappet Surface
Pitted and
Indented

(h) The tappet face of the compressor piston be made of a suitable hardened material to withstand wear and resist indentation.
